# SUE Solves As-Built Deficiencies, Gathers Accurate Risk Assessment Data

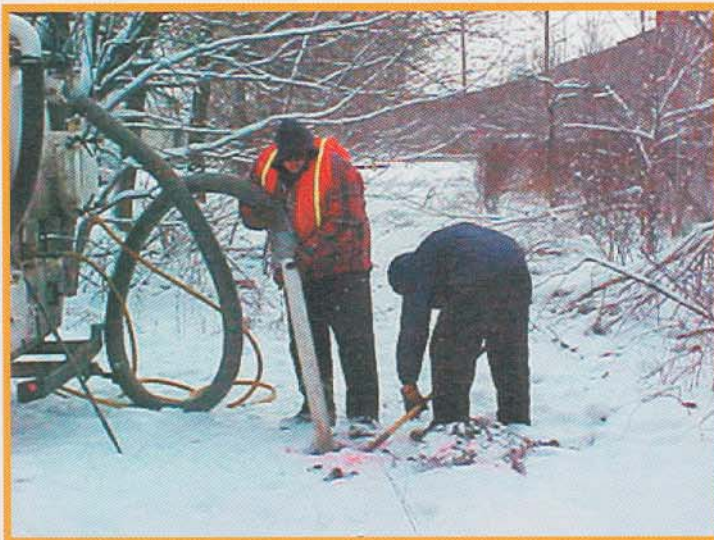
Photo #1: Field crews completing test holes during winter conditions.

In total, 47 test holes were installed at key locations to give precise horizontal and vertical location data. As can be seen in photo #1, the test holes were installed using air-based vacuum excavation equipment, which raised the RMN staff's comfort level, considering the sensitive nature of excavating directly above large-diameter distribution mains, particularly in cold weather. The spacing between test holes was dependent on the specific site conditions and the confidence that the field crew had in the signal that they received from the designating instruments.
